**National Highway
Traffic Safety
Administration**

Case Vehicle (A): 1998 Ford
Type: F-150 XLT Super cab 4 x 2, 3-door pickup
Driver: 43-year-old female
CDC: 01-FDEW-3

Veh. (B): 1989 Ford
Type: Festiva LX, 2-door hatchback
Driver: 17-year-old female
CDC: 12-FDEW-3

SITUATION

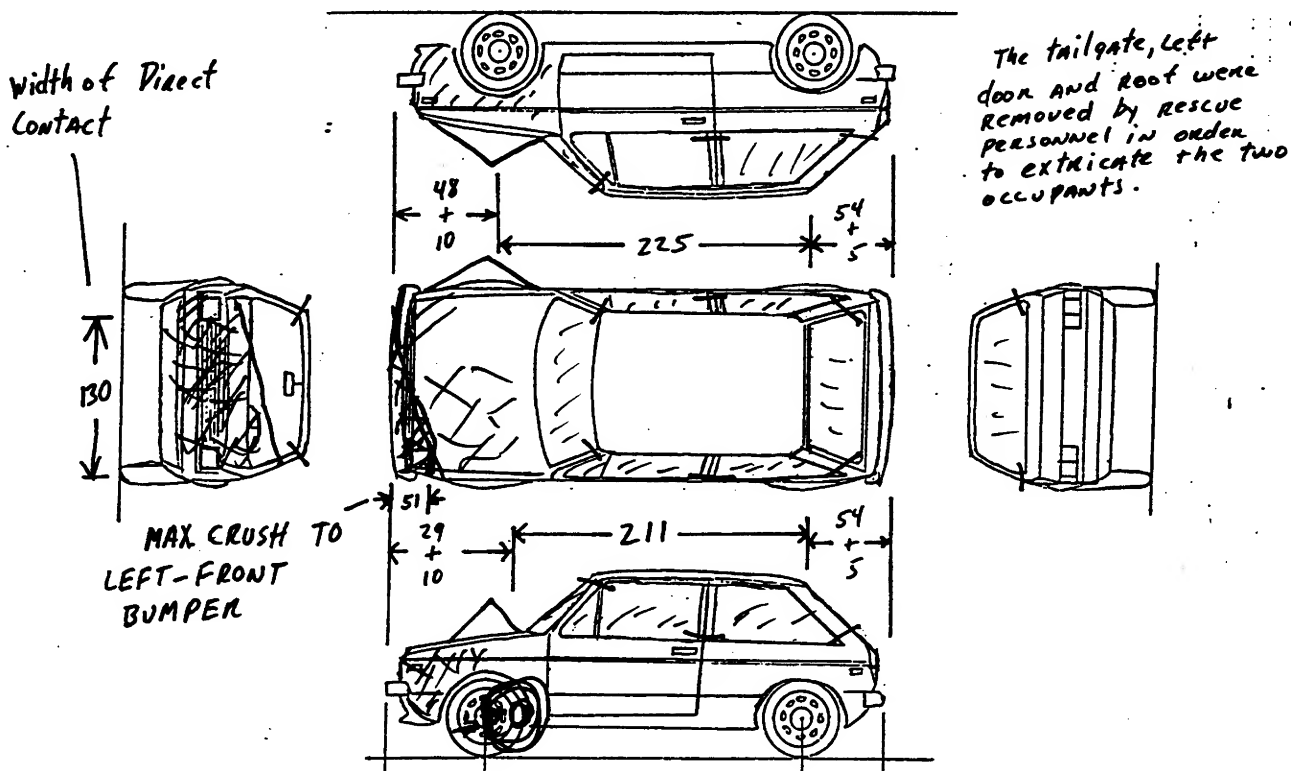
VEHICLE DAMAGE

(Slide 5) Damage to vehicle (B) was severe. (Slide 6) The direct damage to vehicle (B) began at the left-front bumper corner and extended 84 cm to the right. (Slide 7) The maximum crush was 51 cm to the left-front bumper. The left wheelbase was reduced 18 cm and the right wheelbase was reduced 5 cm. (Slide 8) Rescue personnel cut the upper A- and B-pillars to remove the roof, the hatchback, and (slide 9) the left door in order to extricate the occupants.

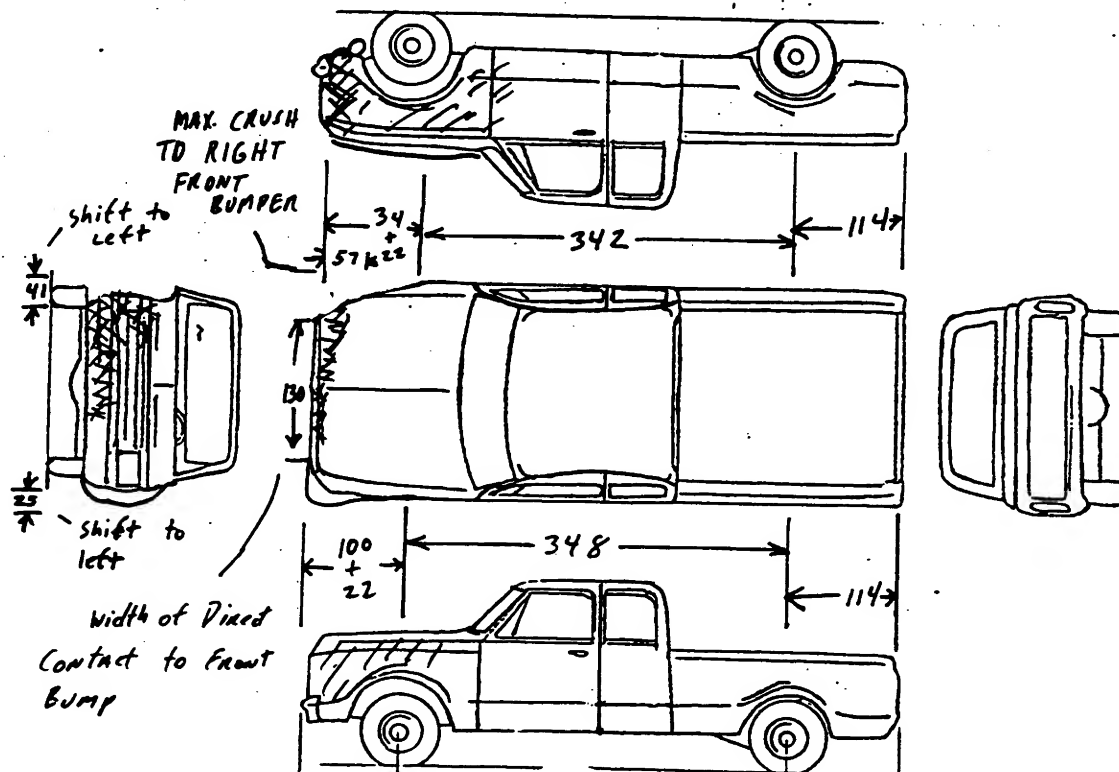
VEHICLE DAMAGE

(Slide 3) Direct damage to case vehicle (A) began at the right-front bumper corner and extended 130 cm to the left across the front, resulting in 70-percent vehicle overlap. (Slide 4) The maximum crush was 57 cm to the right-front bumper.

(Slide 18) Damage to case vehicle (A) was moderate. In the front, (slide 19) the right headlight assembly, the bumper, the grille, the hood, the hood latch, and the right hood hinge were damaged. The right bumper corner was shifted 41 cm to the left, and the left bumper corner was shifted 25 cm to the left. The hood latch was damaged and jammed closed, but had been pried open by rescue or tow yard personnel. The hood was buckled and the rear edge of the hood was slightly elevated, but it did not contact the windshield. (Slide 20) There was a stress crack along the right-lower portion of the windshield. (Slide 21) The right upper and lower radiator supports were pushed rearward and to the left.

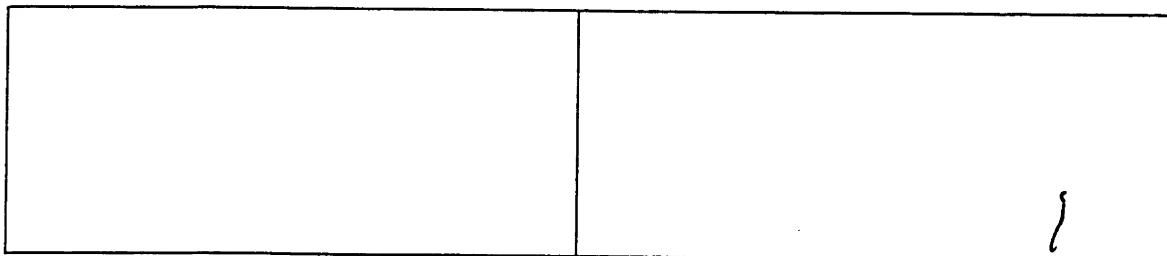
LOCATE AREA OF WINDSHIELD INTEREST OR DAMAGE WITH DIMENSIONS (VERTICAL & HORIZONTAL) ON THIS DIAGRAM OF THE WINDSHIELD AS VIEWED FROM INSIDE.

CRACKED

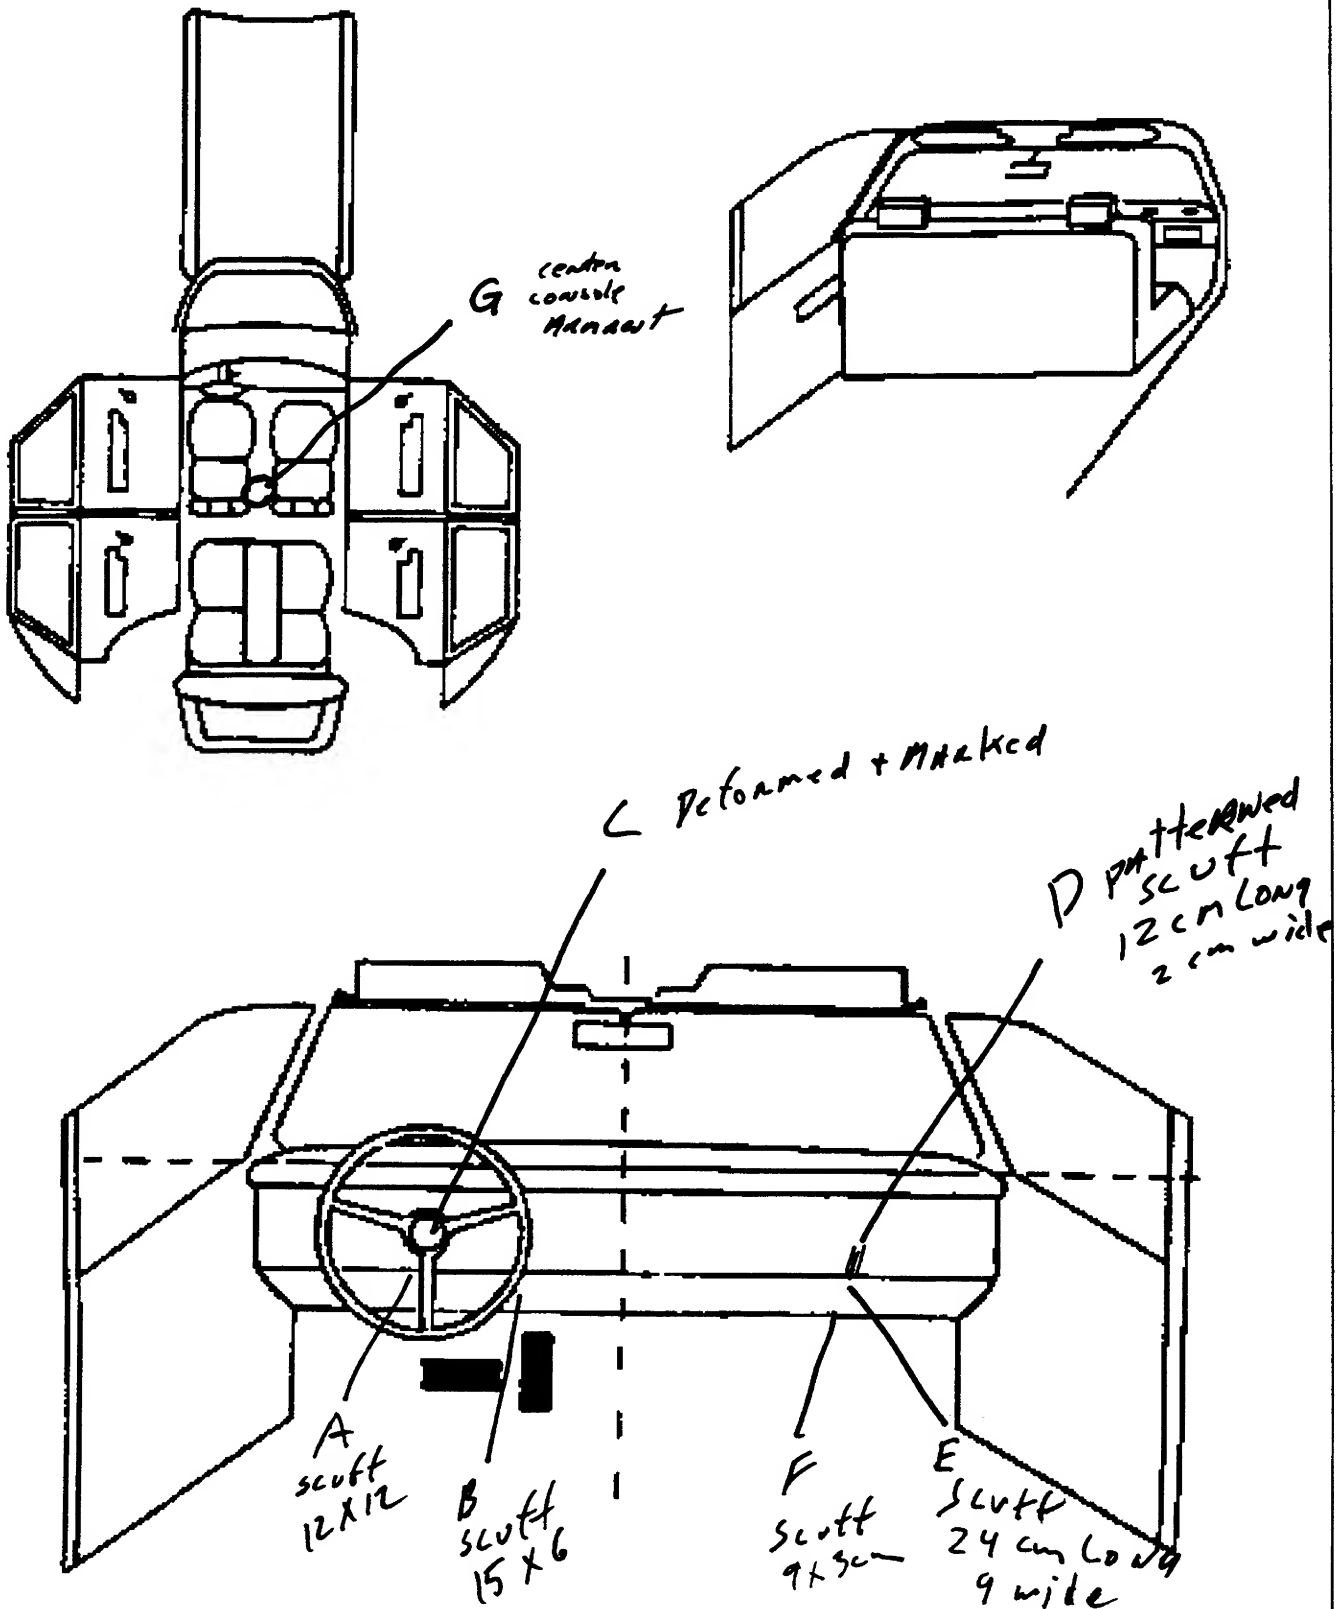
VEHICLE OCCUPANT CONTACT DIAGRAM

Contact	Interior Component Contacted	Occupant No. if Known	Body Region if Known	Supporting Physical Evidence	Confidence Level of Contact Point
A	Knee Bolster	DR	Lt. Knee/leg	Scuff	1
B	"	DR	Rt. Knee/leg	Scuff	1
C	SW Hub	DR	Handy forearm	Deformed + marked	2
D	Glove box	RF	Rt. leg	Scuff	1
E	"	"	"	Scuff	1
F	Duct	"	"	"	1
G	center console	RC	Arms/face	Scuff	2
H					
I					
J

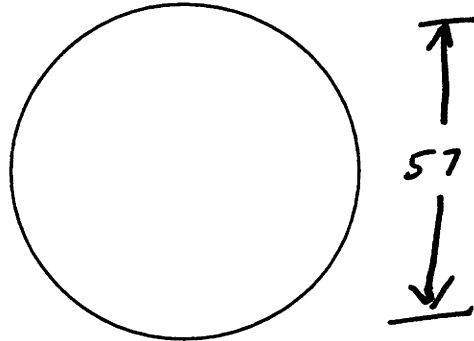
NOTE AND DESCRIBE ANY AIRBAG CONTACT OR
DAMAGE ON DIAGRAM BELOW:

2 VENTS @
11 + 1 o'clock

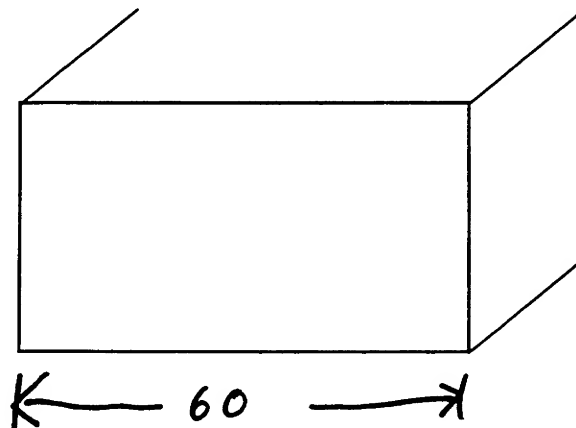
NOTE AND DESCRIBE ANY AIRBAG CONTACT OR
DAMAGE ON DIAGRAM BELOW:

NO VENTS
17 TALL
39 WIDE
